## ROOF PROJECT UPDATE

**31 January 2023**

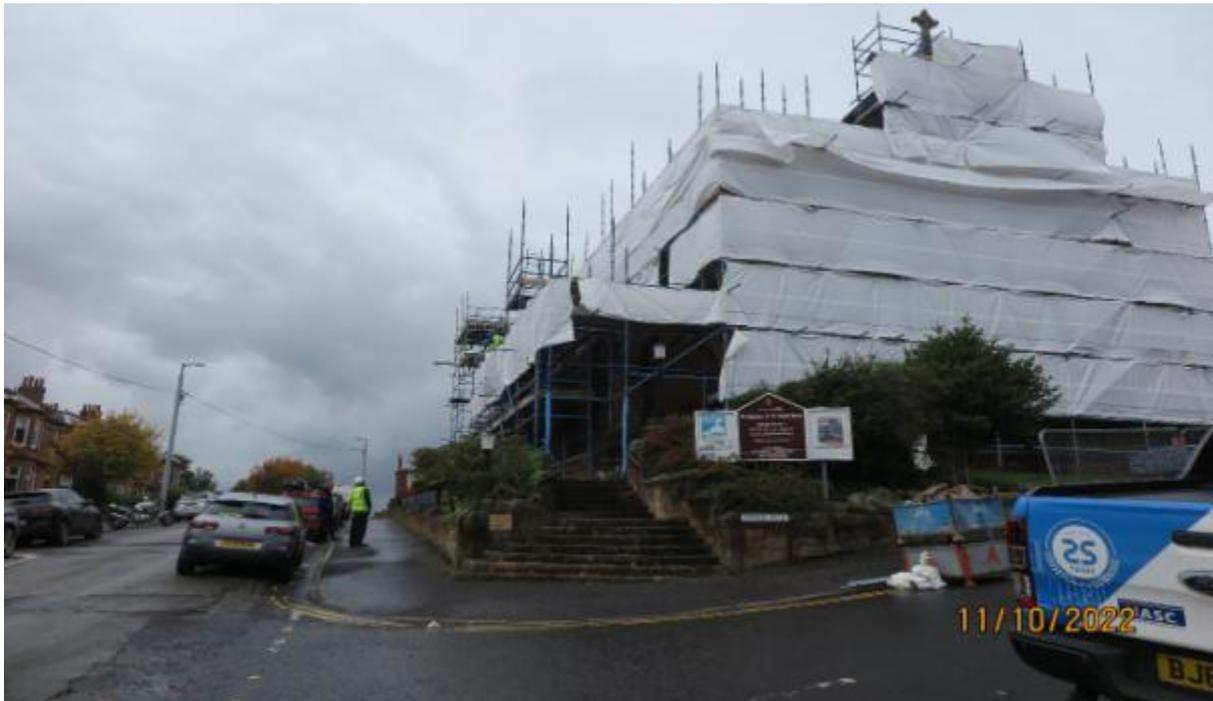
The white monoflex covering intended to give protection to the stonemasons did not do well in the gales and is not being replaced.

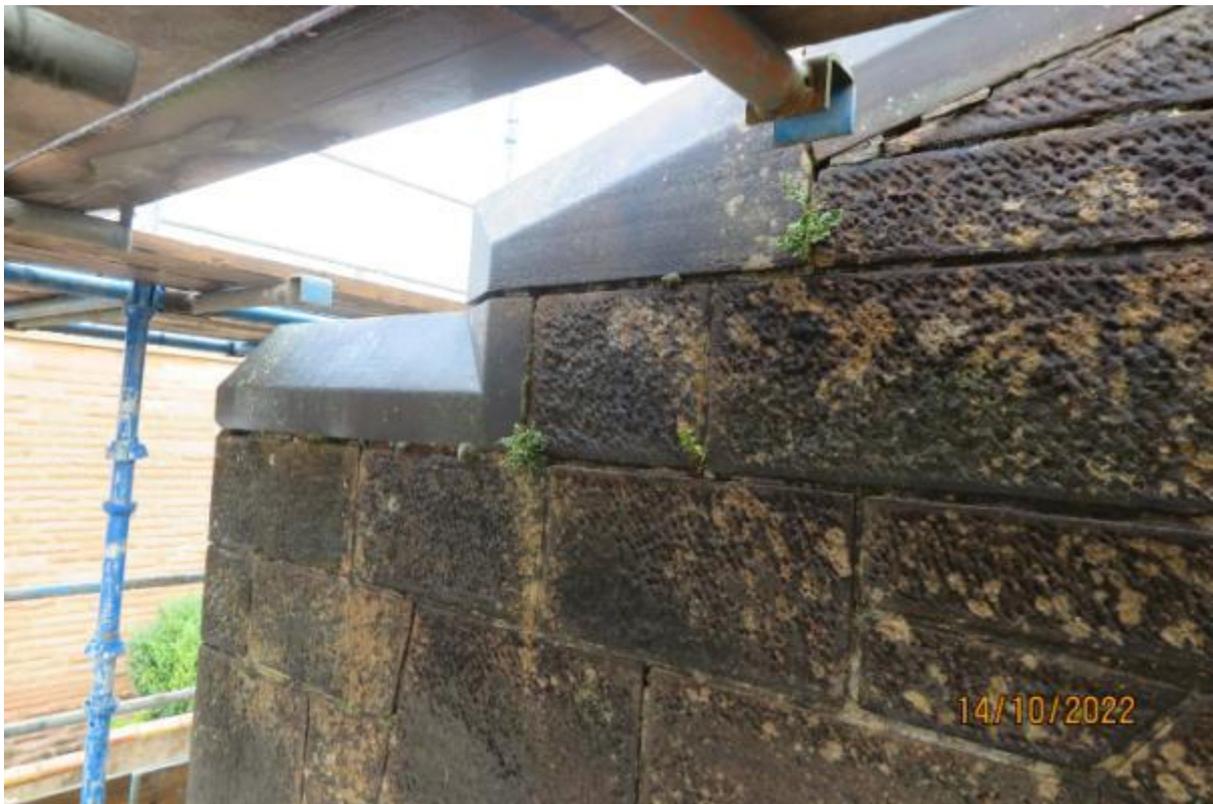
**Above** stripping underway      **Below** gaps in stonework and growing vegetation

The gaps shown here and in the photo below are caused by years of rain washing the mortar out of the joints. The result is water entering the building through the gaps

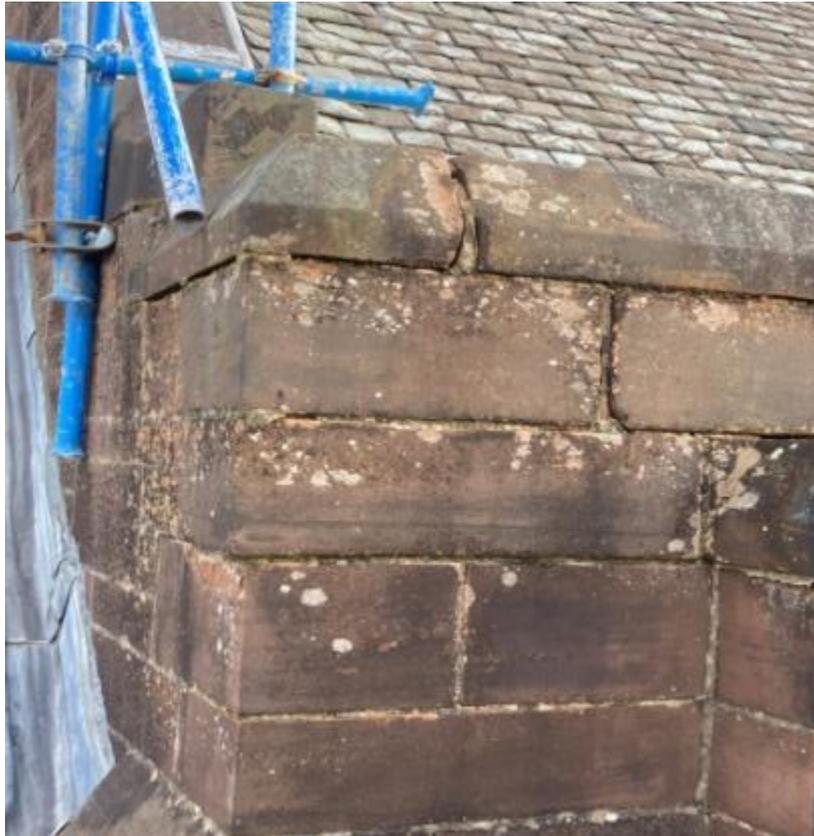
Overall our fabric has a lot of lead in vital gutters and skews. The leadwork thins with age, cracks and has been subject to repair and patching. It now needs replaced

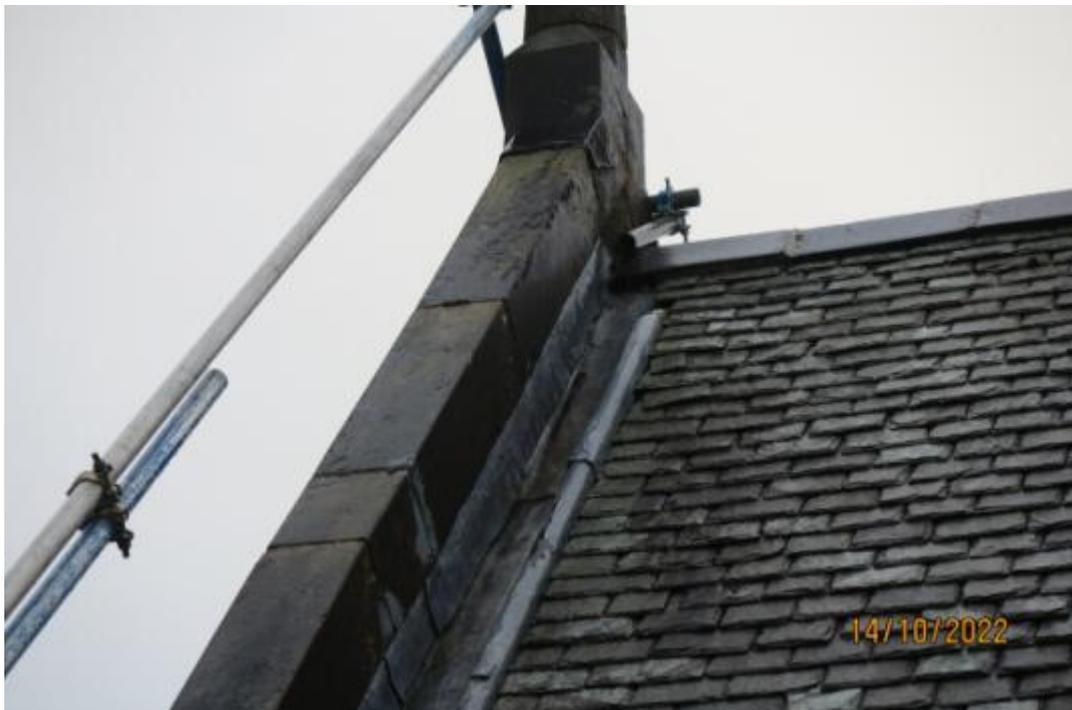
See here gaps in the cope stones and the worn lead skew

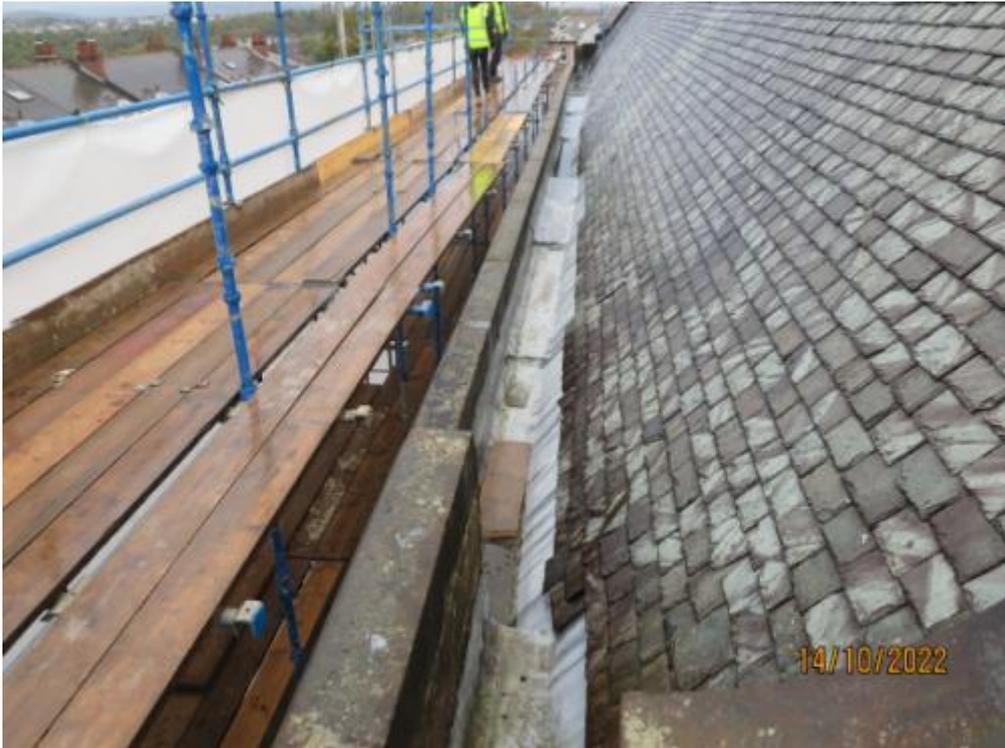
Above is the gutter along the south aisle where there has been persistent water ingress and years of running repairs. The photo on the left below shows rot and the photo on the right shows extensive rot, due to cracked lead and a faulty outlet pipe

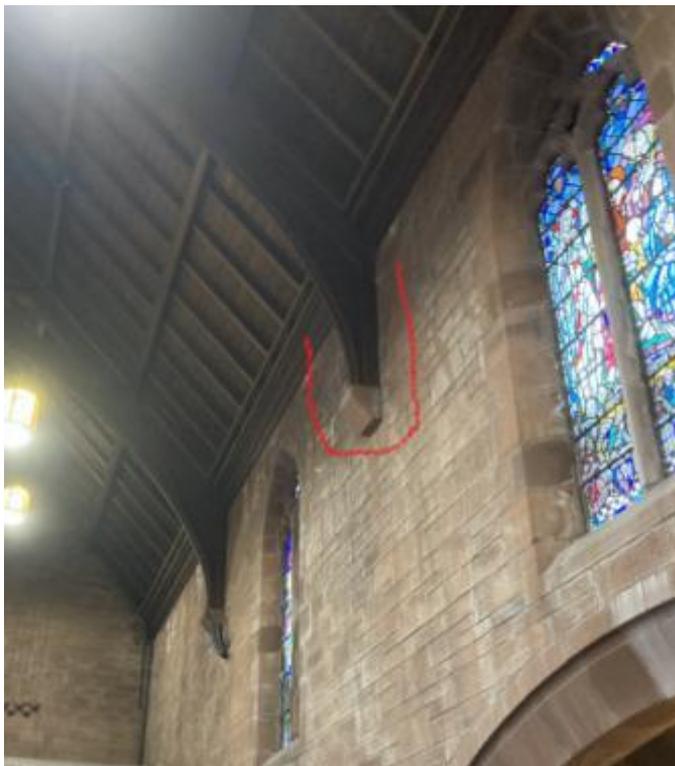
Just as this note was being prepared our specialist contractor, who identified the rot in the high level lead valley gutter on the south aisle where we have had problems of water ingress for years, was in touch to request scaffold in the sanctuary to allow him to reach and inspect the main beam outlined in red. He needs to see that the rot he found in the gutter caused by cracked lead, a birds nest, and a faulty outlet has not penetrated to affect this single main beam (the others are fine)
